A 35 year old male employee was removing a high pressure hydraulic hose from an aluminum die-casting machine accumulator, when it fatality struck the employee in the neck & chest. The 3,000 ton die cast machine had developed a leak within the accumulator bottle. The accumulator bottle contains a piston that pressurizes and moves hydraulic fluid into the die cast machine using the force of nitrogen gas. Pressures in the accumulator can range from 1,500-4,5000 psi. Before the accumulator bottle can be serviced, the nitrogen gas must be removed or isolated. On the day of the accident, the victim was attempting to service the leaking accumulator bottle, and proceeded to lock out the nitrogen. Both the accumulator and nitrogen bottle were purged of pressure. However, the hose connecting the nitrogen bottle and accumulated was not purged and maintained approximately 1,500 psi of pressure. The victim then used a scissor lift to position himself to remove the 4-foot hose from the accumulator bottle. While removing the hose from the accumulator bottle, the victim was struck twice in the neck and chest with the hose, resulting in fatal injuries. A co-worker climbed onto the lift to lower it,

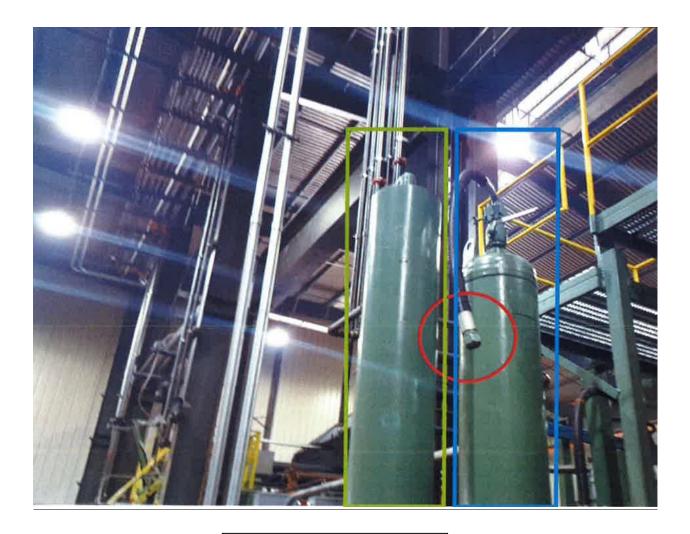
Photo 1 of 4 – Photo shows the #80 die cast machine. The nitrogen gas bottle is shown in the blue outline and the accumulator bottle is in the green outline. The red circle indicates the end of the hose that struck the victim.

1910.147(c)(4)(ii)(B)	Specific procedural steps for shutting down, isolating,
	blocking, and securing machines or equipment to control
	hazardous energy were not implemented. In that the
	employer's energy control procedure for the #80 die cast
	machine did not include and implement specific steps to
	control the potential hazardous energy when removing the
	nitrogen gas and accumulator bottles.

29 CFR 1910. 147(d)(5)(i)	Following the application of lockout or tagout devices to
	energy isolating devices, all potentially hazardous stored or
	residual energy was not relieved, disconnected, restrained,
	and otherwise rendered safe. In that the employer did not
	ensure a method was in place to ensure pressure was released
	from the nitrogen gas and accumulator bottles located on the
	#80 die cast machine before removing the connecting hose.

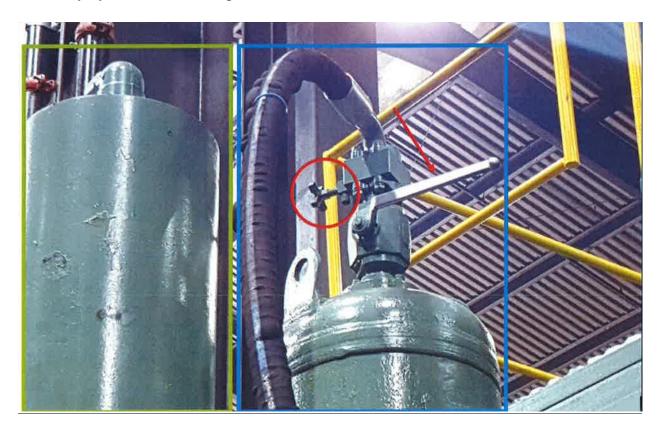
Photo 2 of 4 – Photo shows the nitrogen gas bottle in the blue outline and the accumulator bottle in the green outline. The ¹/₄" valve (red circle) is used to release the nitrogen gas pressure form the accumulator bottle, and the 2" valve (red arrow) holds the pressure inside the nitrogen bottle

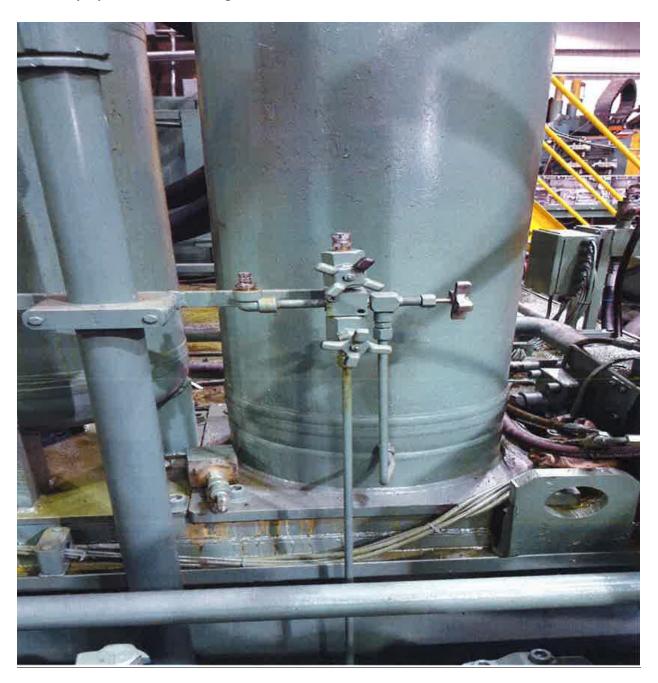
Photo 3 of 4 – Photo shows the drain valves near the bottom of the nitrogen bottle on the #80 die cast machine.

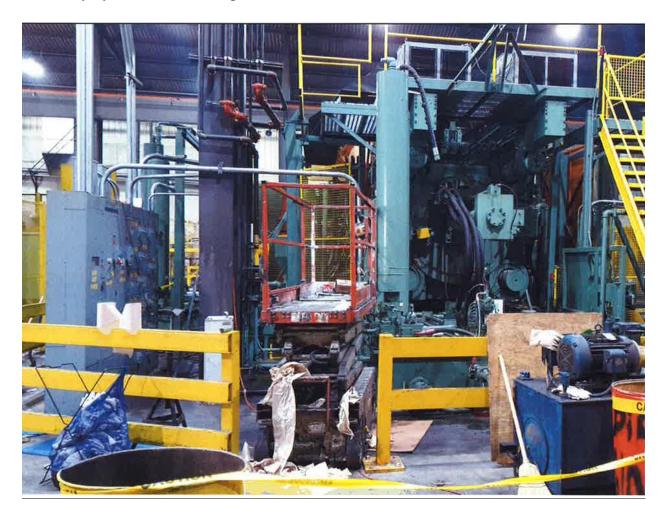
Photo 4 of 4 – Photo shows the scissor lift used to lift the victim to release the pressure at the top of the nitrogen bottle on the #80 die cast machine and remove the 4 foot hose
